**COVER LETTER**

This Combustion Survey Manual has been compiled from the information taken while surveying the Plant 1 facility. The survey manual is divided into the following sections:

Refining Co. 23-Mar-2022

Plant Plant 1 Unit DU-5 Heater F-35

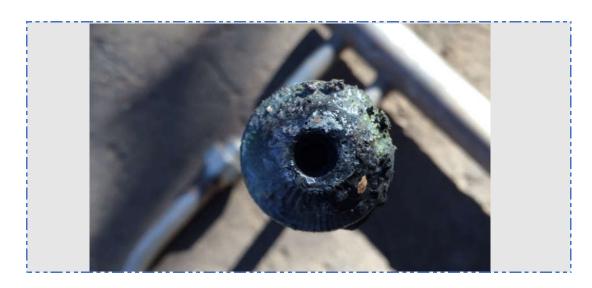
Burner 10 tip plugging and coking buildup.

<u>Acti</u>	on Items:								
Rep	lace all necessary parts on previously mentioned burners.								
	For help with spare parts follow instructions on spare parts lists in this report or contact Zeeco at Aftermarket_inquiry@zeeco.com, or contact your local Zeeco End User Rep for other questions.								
For assistance with onsite support, please contact Zeeco Global Field Services at									
	Zeeco Inspection Checkup								
Pla	nt Plant 1 Unit DU-5 Heater F-35

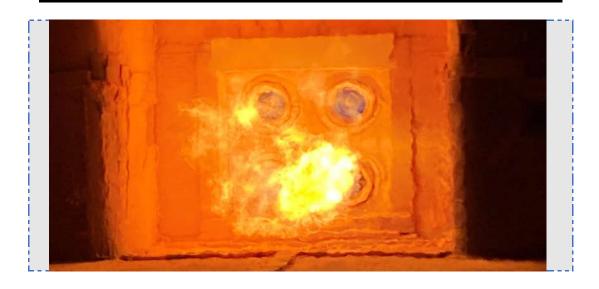
Burner 17, lower left burner, with obvious flame appearance difference.

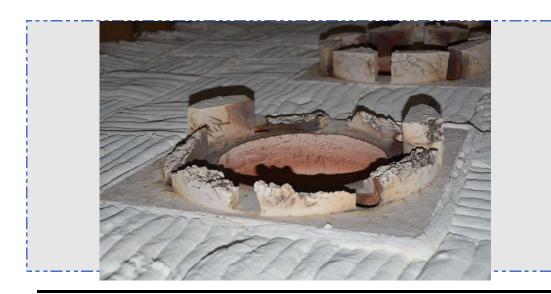
Rec	ommendations Continued:								
3	Burner 3, shut off due to instability from coking and possibly damaged cone. Clean and inspect cone at next available shutdown, if the cone is damaged, misshaped or broken, replace cone.								
	Will Improve: Safety Efficiency Ease of Operation Ease of Maintenance								
4	Burner 29, severe tile damage. Replace tile at next turnaround.								
	Will Improve: Safety Efficiency Ease of Operation Ease of Maintenance								
5	Check burner draft at individual burners to verify combustion air is balanced from burner to burner, and if they are not, balance this combustion air using individual burner air registers. This can be a tedious process, if onsite assistance is required see contact information for Zeeco Global Field Services below.								
	Will Improve: Safety								
6									
	Will Improve:   Safety Efficiency Ease of Operation Ease of Maintenance

Burner 29 tile sections broken and missing.

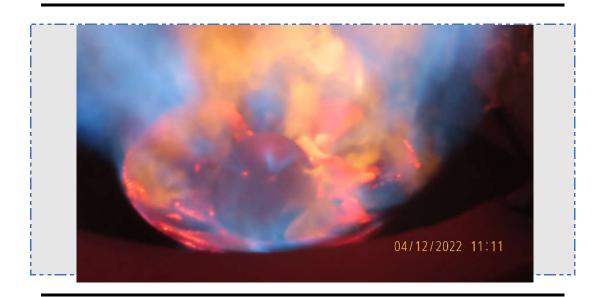
Burner 3 cone and coking build-up.
